UNITED STATES DISTRICT COURT
WESTERN DISTRICT OF WASHINGTON AT TACOMA

THE ESTATE OF CALEB BROWN, by and
through BRITTNEY TEANEY, the Personal
Representative,

**COMPLAINT FOR WRONGFUL
DEATH**

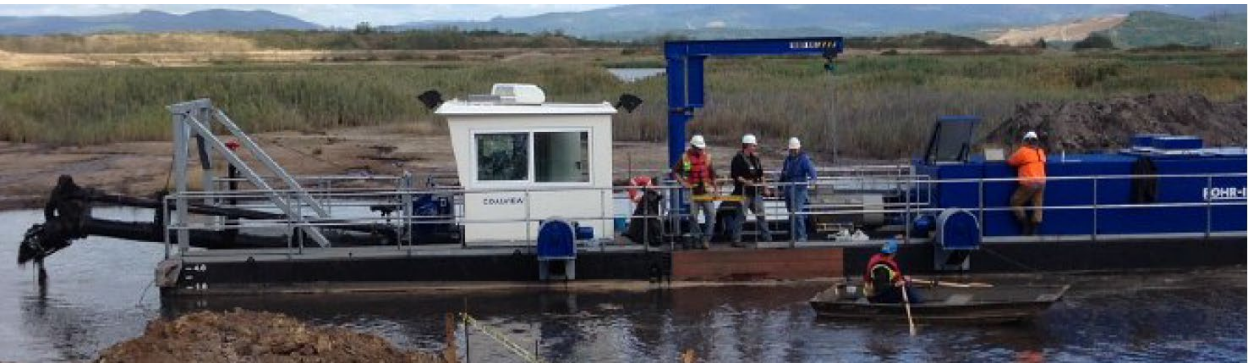
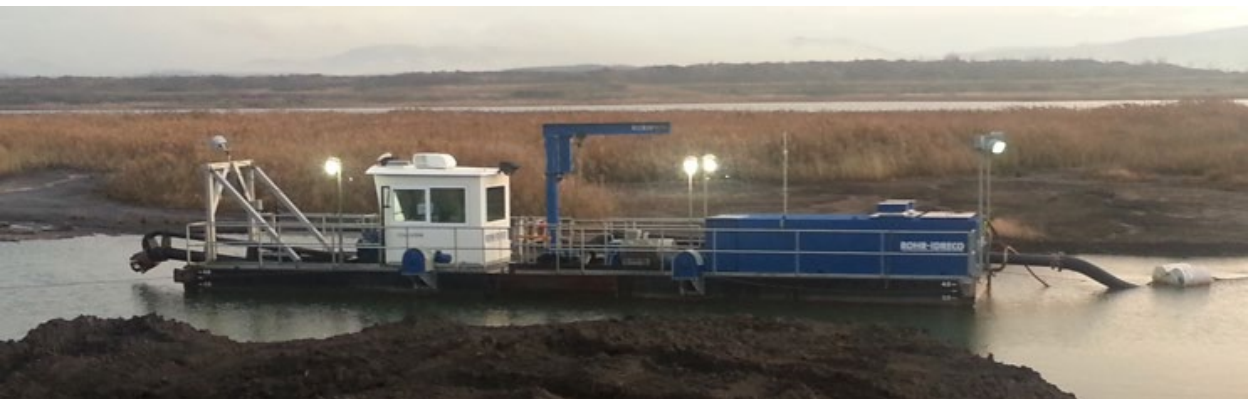
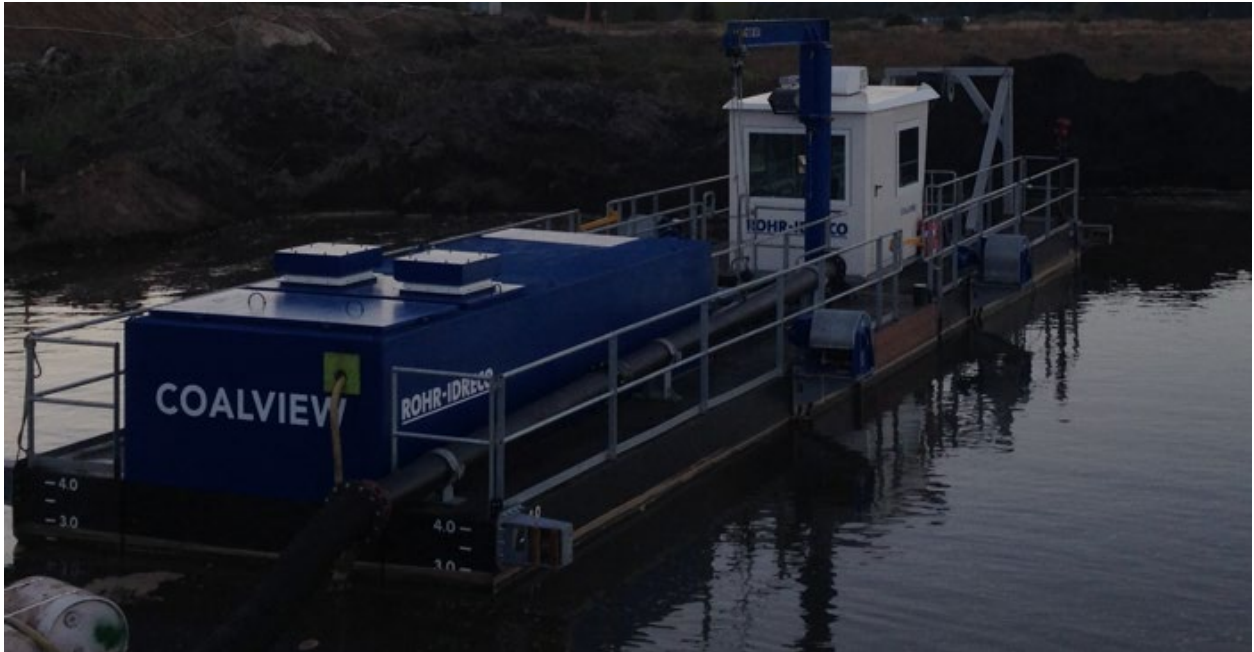
3.17 Defendant Coalview Recovery Group, LLC originally provided a dredge manufactured by Rohr-Idreco for the project. The dredge used a water jetting head to loosen material from the bottom of the ponds before being delivered to the suction head to be pumped to the Processing Plant through a pipeline.

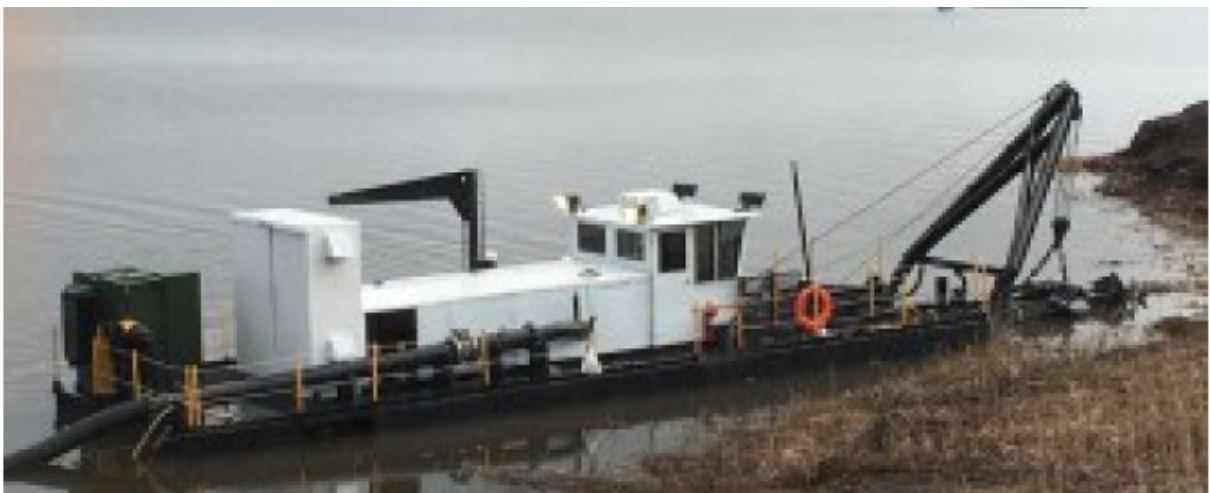
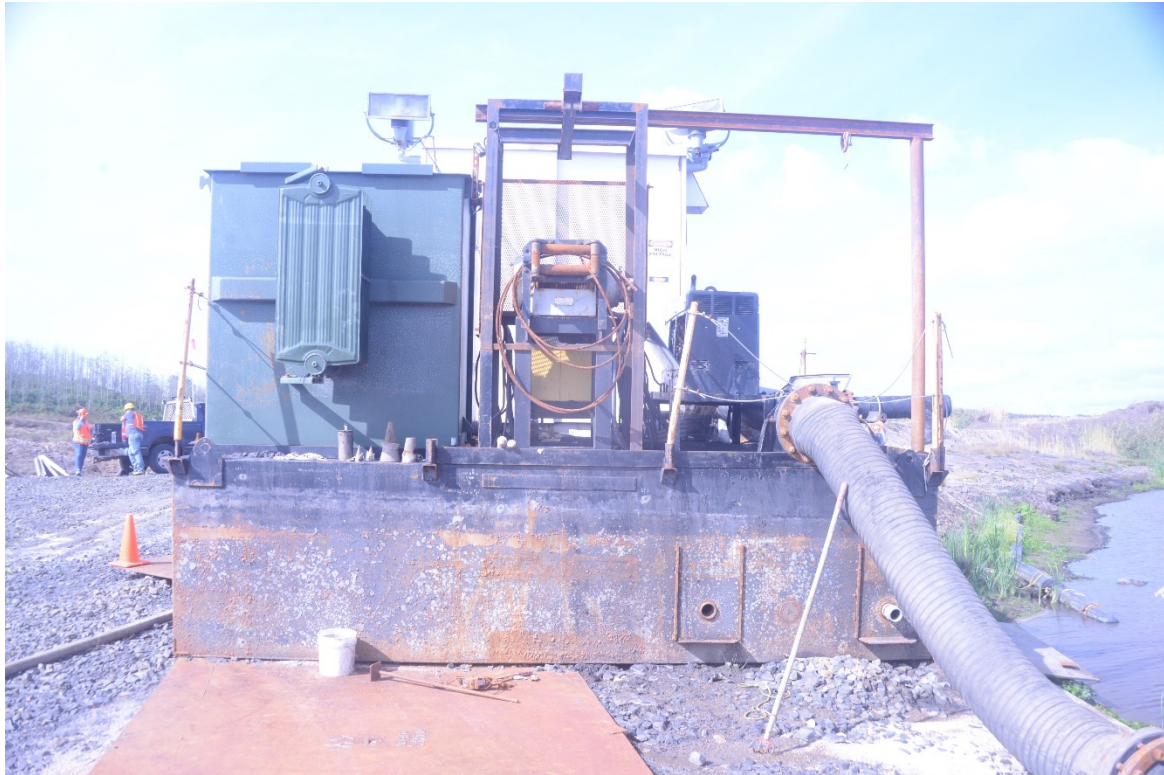
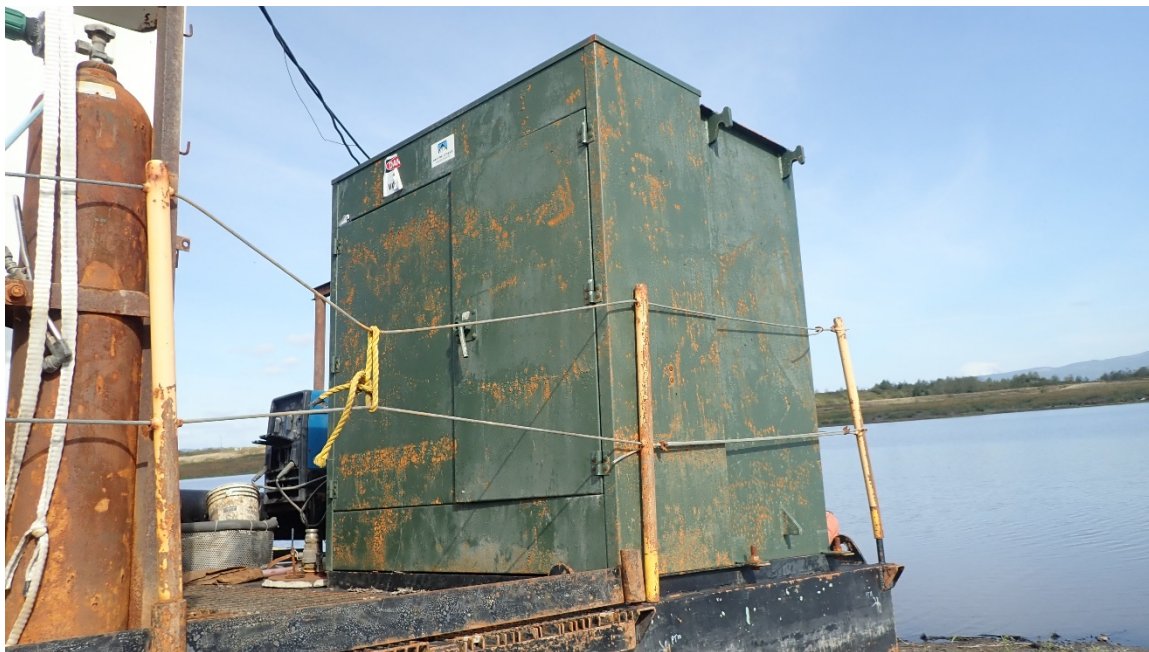
1 3.19 As part of the change of the dredge from diesel to electric, Defendant Dredge
2 Central added a new stern pontoon to support an electrical transformer. A plate on the transformer
3 stated that it weighed 10,140 pounds. A Motor Control Center (VFD House) was also added,
4 located on the stern end of the center hull. Plates on motors on the modified dredge indicated that
5 they weighed hundreds and thousands of pounds.

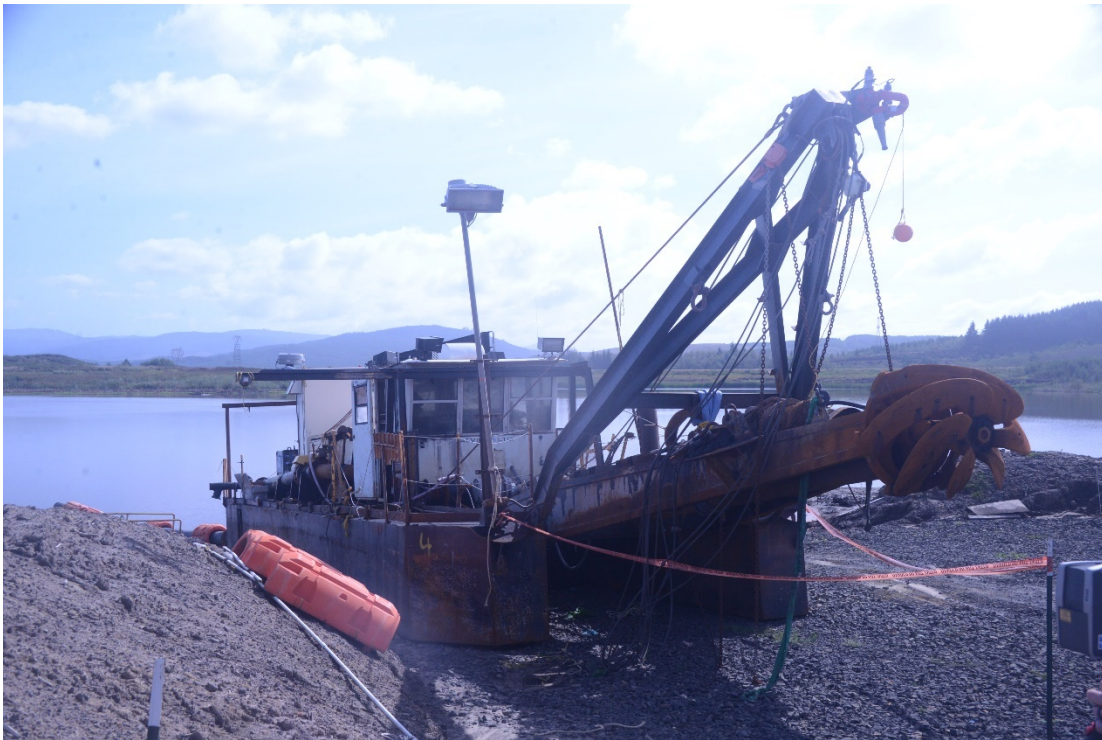
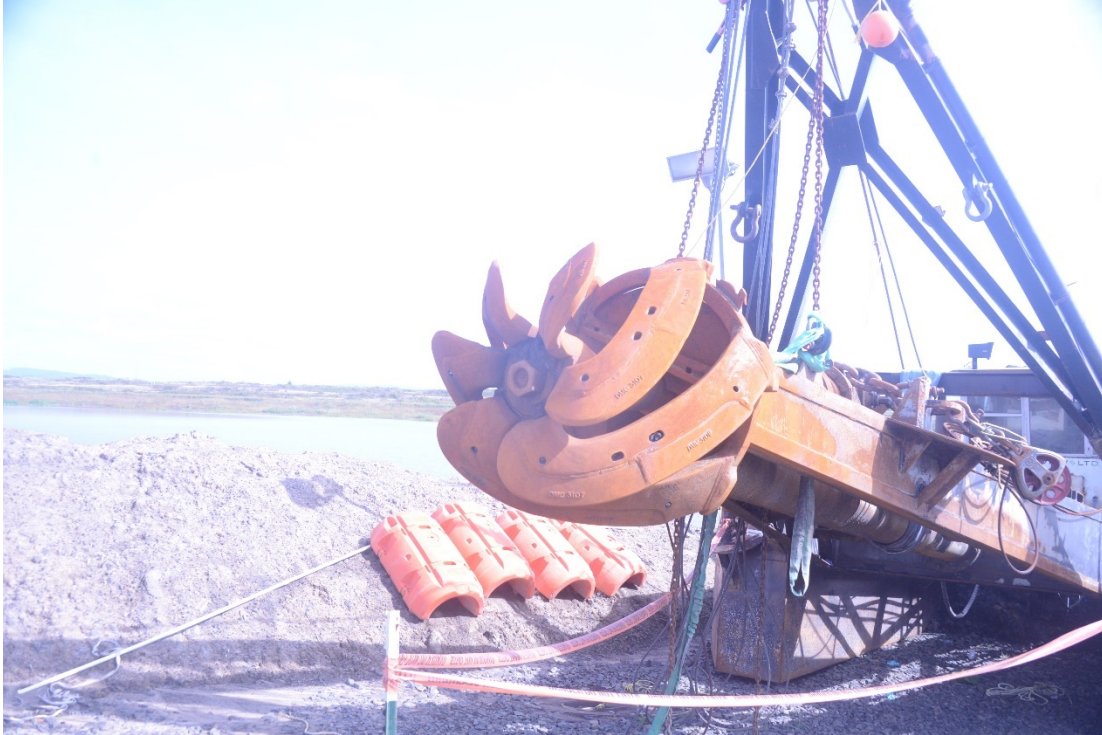
7 3.22 Defendant Dredge Central designed the used dredge with a cutter (auger) head
8 (depicted below) rather than a water jetting head, which the original Rohr-Idreco dredge had.

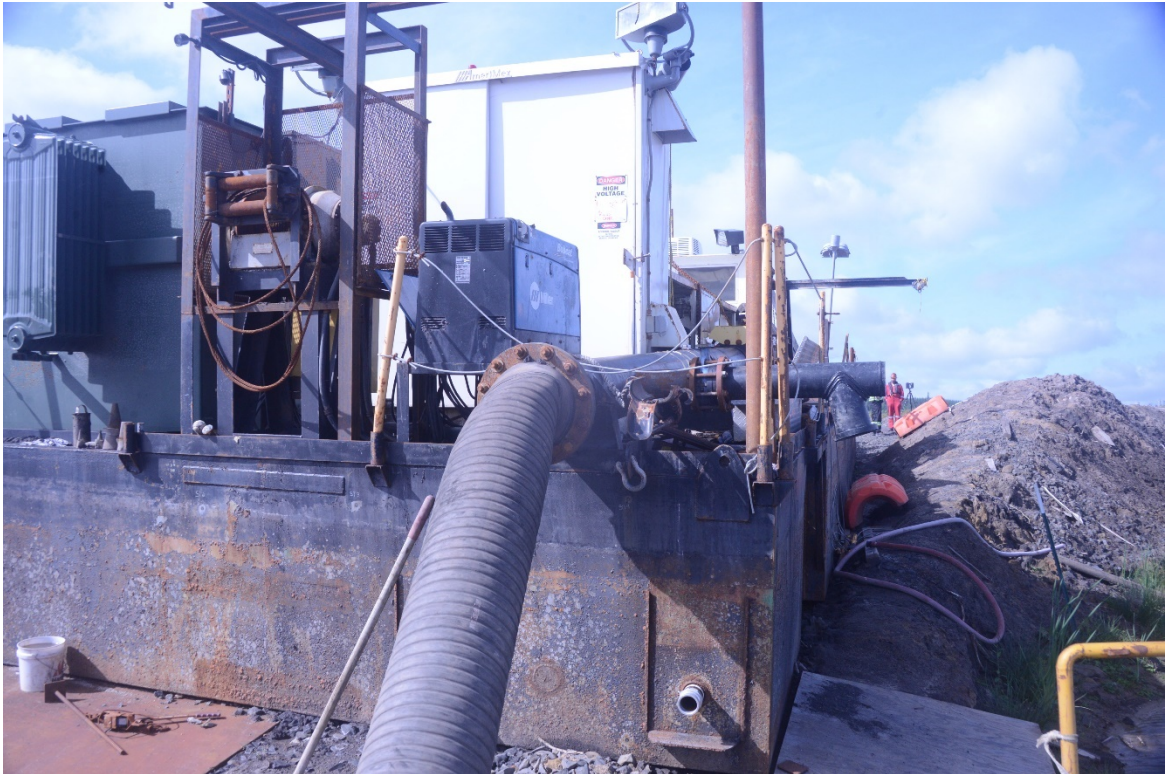
1 3.28 The stern winch was located at approximately the center of the stern pontoon, next
2 to the transformer, and at an elevated position.

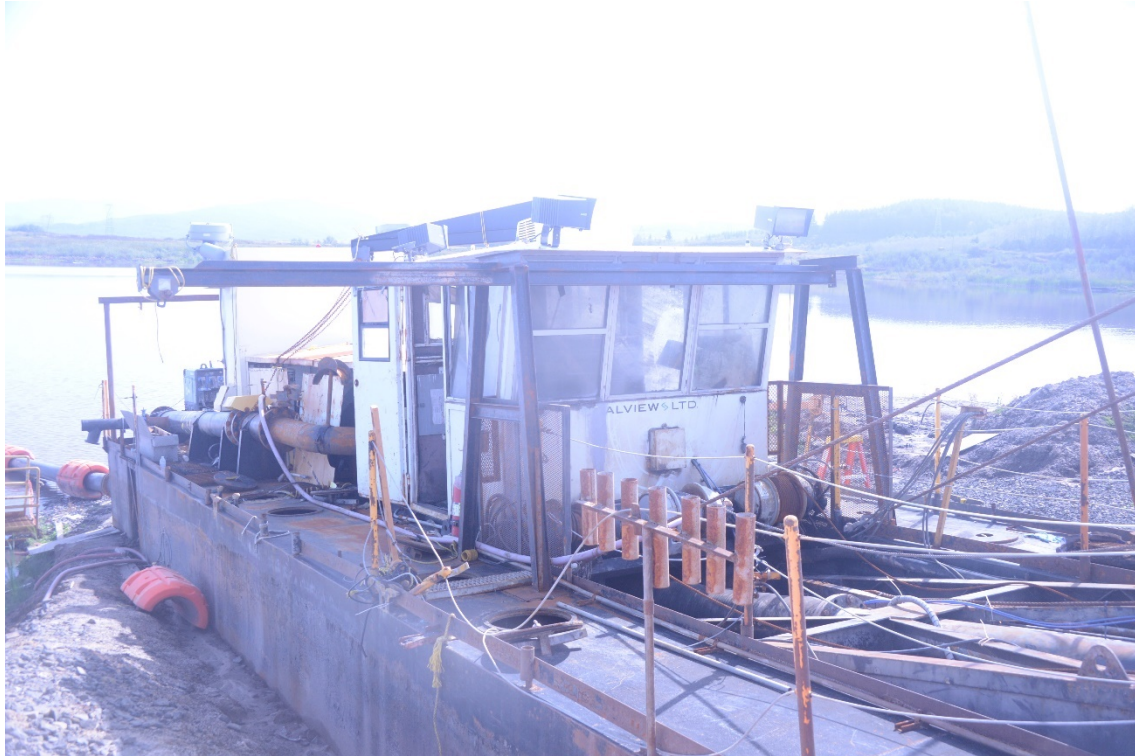
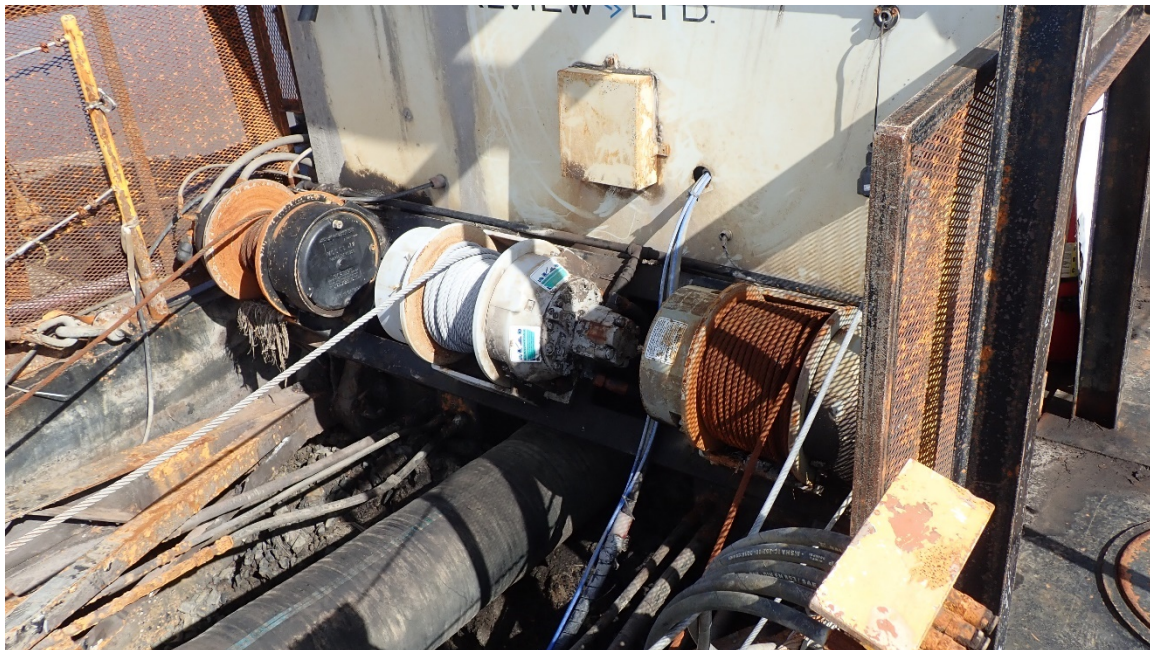
14 3.29 The front starboard and port winches were mounted at the front of the dredge
15 operator's cabin.

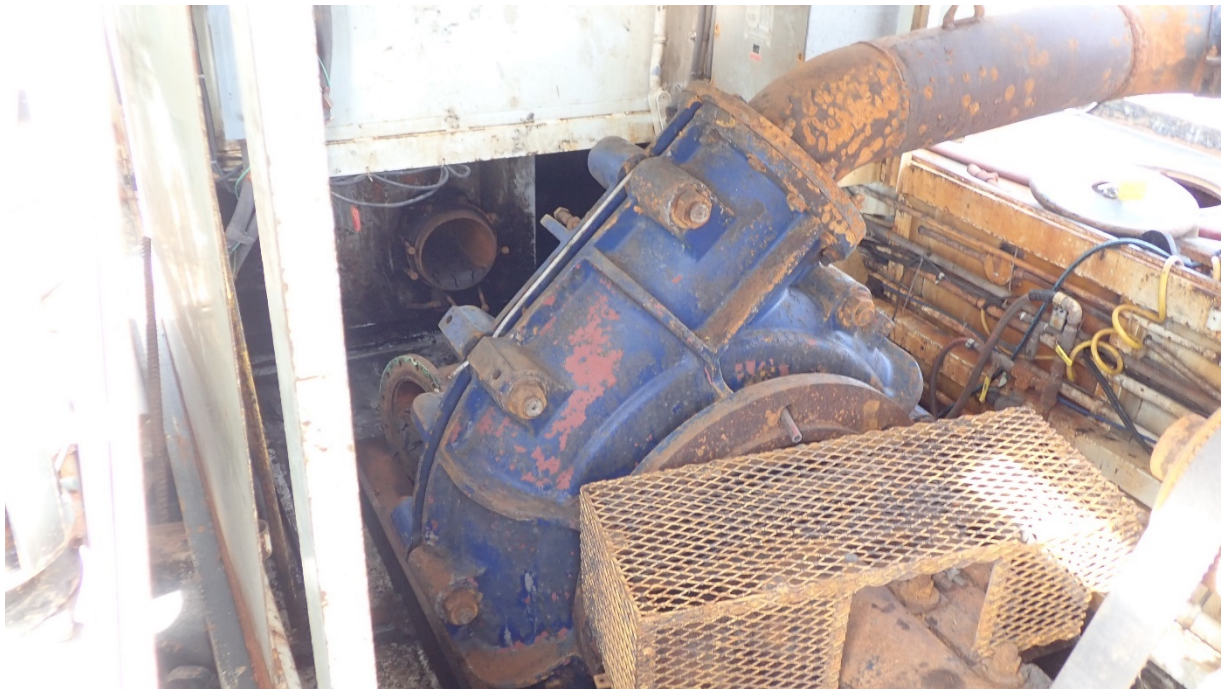
5 3.33 When the dredge was modified by Defendant Dredge Central, the slurry pump that
6 came with the dredge was replaced with a larger, heavier model. The larger slurry pump required
7 reinforcement of the floor of the center hull to support it.

8
9
10
11
12
13
14
15
16
17
18 3.34 The slurry pump, powered by a 500 horsepower electric motor, pulled the material
19 loosened by the cutting head into the inlet pipe on the dredge. (The original slurry pump was 400
20 horsepower.) The slurry pump pushed the slurry into a discharge pipe and on to the processing
21 plant on shore through a pipeline.
22
23
24

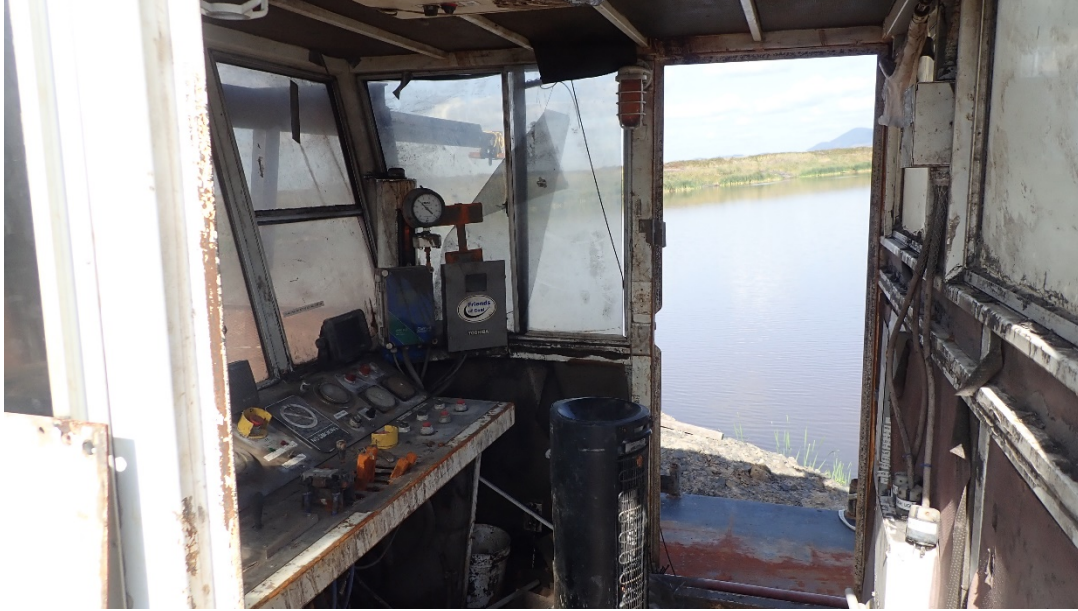
18 3.40 The dredge operator's cabin had metal doors with windows on the starboard and
19 port sides. The starboard door did not line up properly with the door frame, and the plunger of the
20 doorknob did not engage the door frame. Opening and closing the starboard door required
21 significant force.

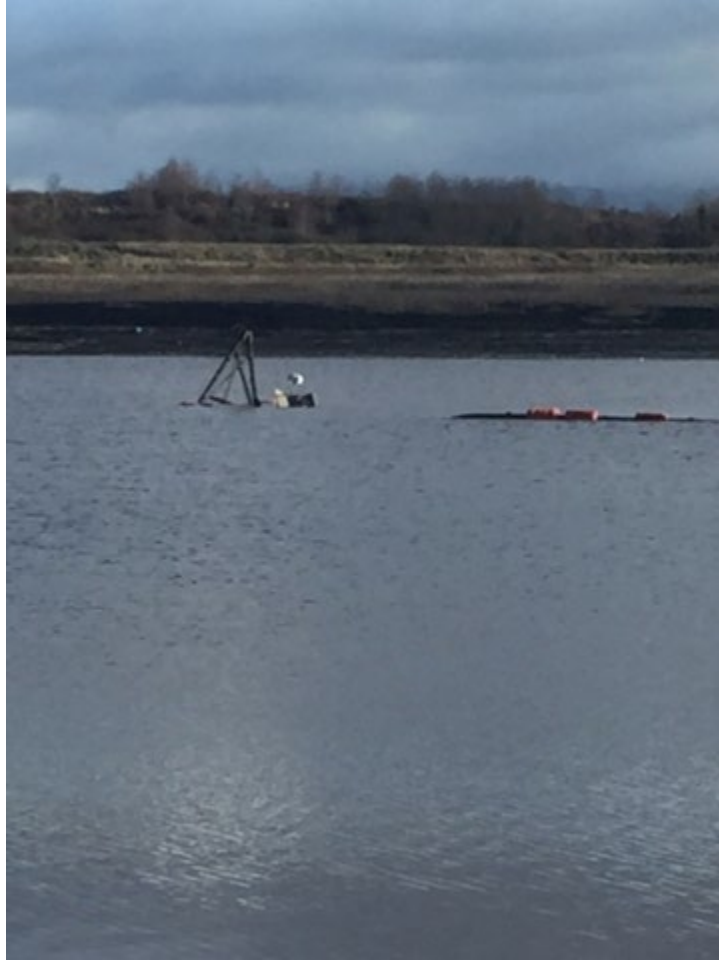
12 3.48 Mr. Rumley then traveled by boat to check on the dredge. When he reached the
13 dredge, he found that it had sunk, with only the A-frame protruding out of the water. The dredge
14 had sunk in about 20 feet of water.

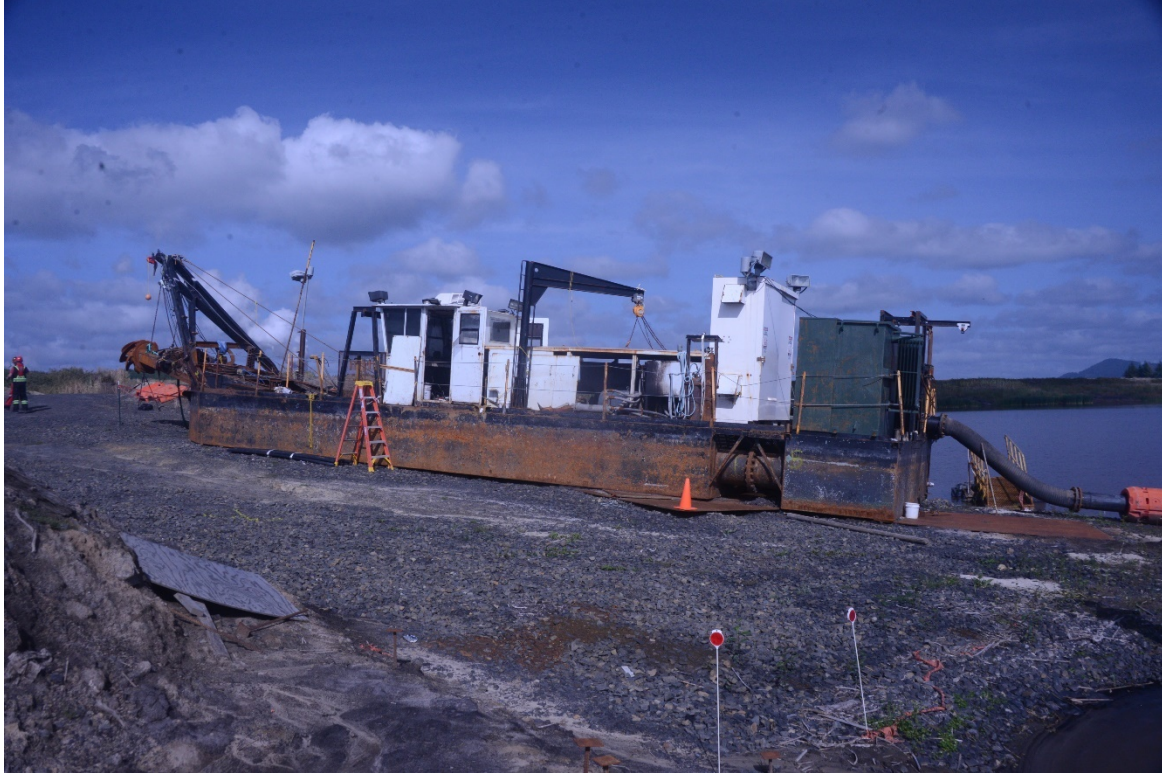
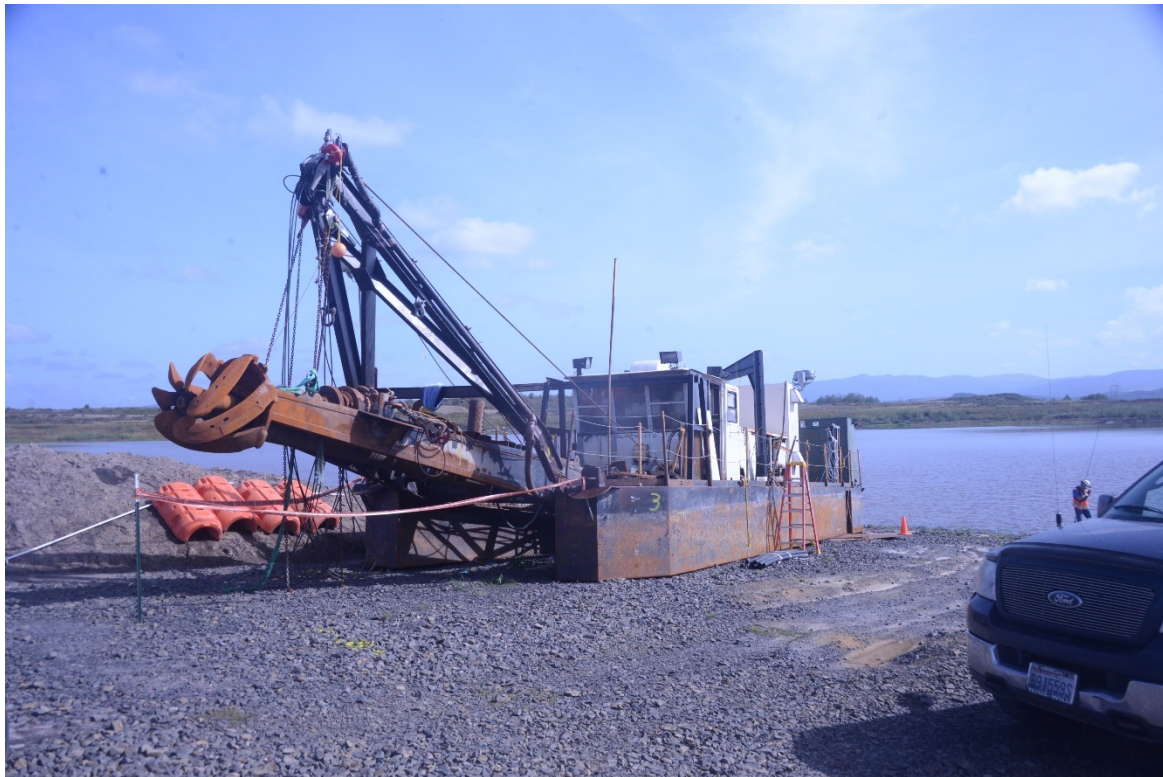
9 3.53 The dredge was recovered and inspected on April 11, 2019. The hatch for the
10 starboard compartment of the stern pontoon was missing, and a portable bilge pump was found in
11 the starboard compartment of the stern pontoon, indicating that Mr. Brown had been pumping
12 water out of the starboard stern pontoon. There was a new doorknob assembly in a box in the
13 operator's cabin that had not been installed.

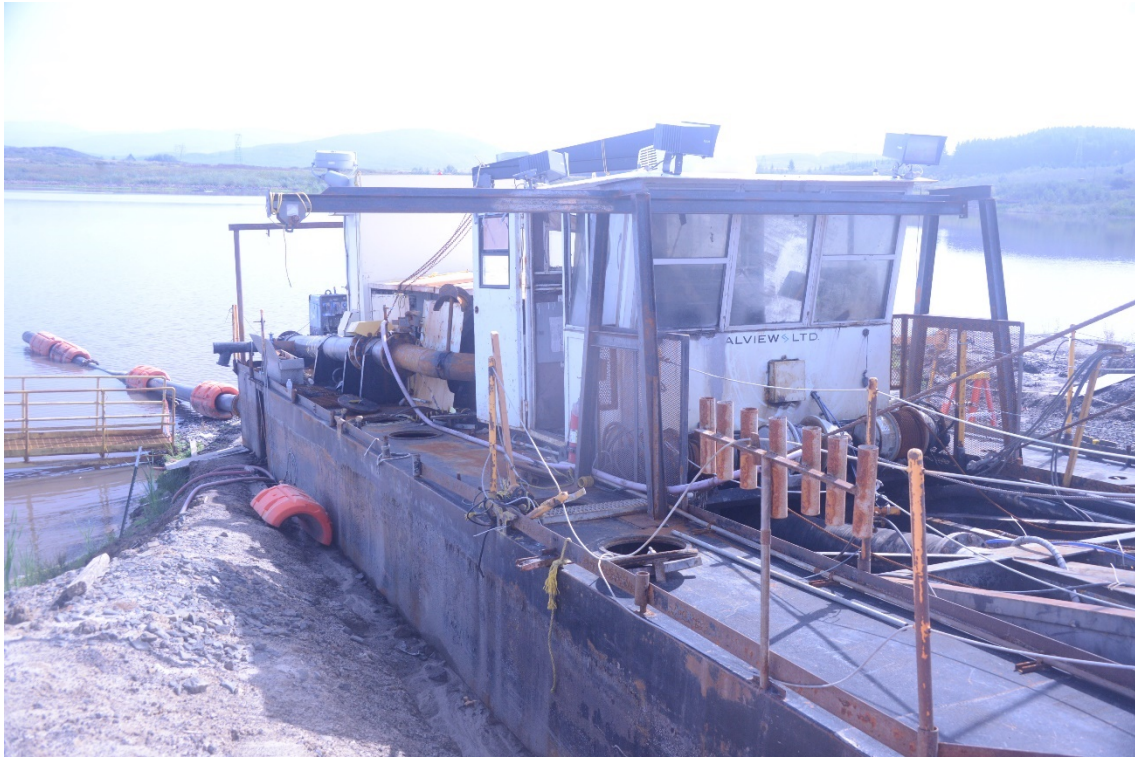
1 3.54 Investigators filled the pontoons with water after the dredge was recovered, to test
2 for leaks. The first and fourth compartments on the starboard pontoon leaked.

3
4
5
6
7
8
9
10
11
12
13
14 3.55 The fourth compartment on the starboard pontoon had an area of deterioration on
15 its bottom outside weld seam that measured 31 inches long. Within that 31-inch area, there were
16 two cracks approximately 6.5 inches long, and an approximately one-half inch hole located
17 between the cracks.
